Conservation Planning Guidelines and Design of Melaka Heritage Shophouses

Noorfadhilah Mohd Baroldin, Shamzani Affendy Mohd Din

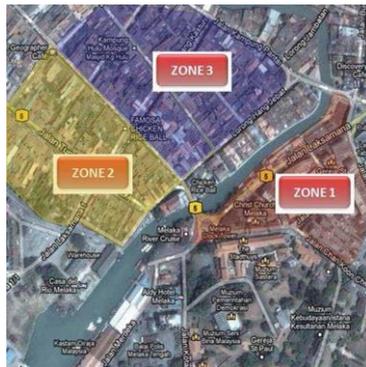
Figure 1: Study Zone

The study zone is one of the oldest city areas in Malaysia and has a history that traces back to the Melaka Sultanate. It is located in a strategic location in the heart of the Melaka city. It can be seen from the study zone that indicates rapid development, which plays an important role in the development of the city itself.

Zone 1

Zone 2

Zone 3

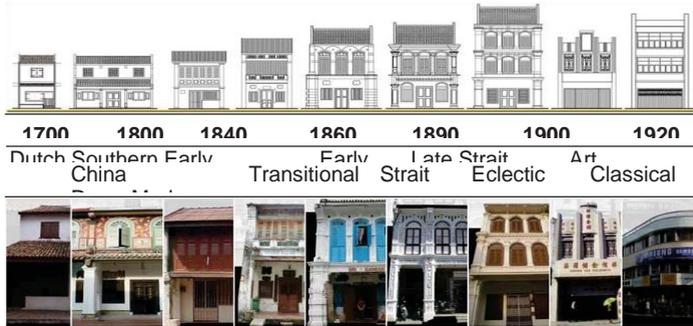
Figure 2: Typology of Melaka Shophouse

In conducting this review, the review will only cover an area, which has been gazetted by the Melaka City Council as the history of the area of the old city of Melaka. The buildings of the selected studies will be the Melaka shophouses, which are in variation of style:

- 1) Dutch style 1600-1700
- 2) Southern China style 1700-1800
- 3) Early Shop house style 1800-1900
- 4) Early Transitional Style 1840-1900
- 5) Early Strait Eclectic Style 1890-1920

- 6) Late Straits Eclectic Style 1920-1940
- 7) Art Deco style 1930-1950
- 8) Early Modern style 1950-1990

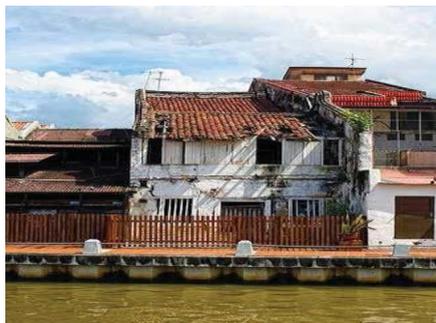
The example in Figure 3 indicates that the owner did not want to rent out their buildings, but let old age consumption. Once the building is no longer safe for occupancy, they would demolish the building for replacement of new buildings.

Figure 3: This is an Example of Dilapidated Shop House Façade at Laksamana Street

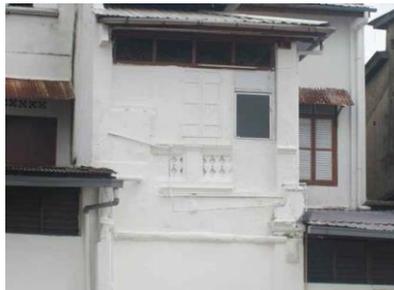
Transfer of ownership since the Dutch era so far has caused lots of broken shops split into lots of smaller ones. By the year 1900, the shop houses have been given new numbers as a result of the division of land into smaller lots. Changing the function of residential buildings to store also has caused many changes were made not only to the interior layout but also to the facade of the shop houses. Front facade demolished and replaced with a larger opening to allow the building functions as a store run. Figure 4 shows that renovation or new construction is not directly related to the scale, context, and the characters surrounding buildings. Design continuity between the old and new units is ignored. This makes the new building seems to stand by itself and appear awkward in their own environment.

Figure 4: The Renovations without Regarded on the Building Characteristic make the Façade seem Lost their History

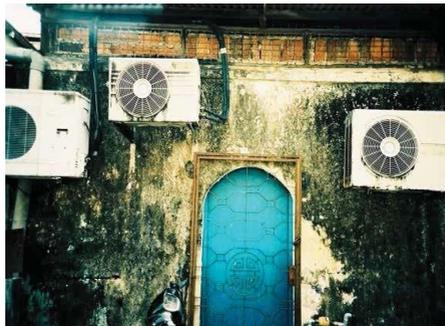
Placing the air conditioner unit on the front facade without thinking too much about facade style can be seen at a shop house in Melaka as illustrated in Figure 5. The effect of the placement of air conditioning unit is crippled without control of the building facade.

Figure 5: Placing Uncontrolled Air Conditioner also can Lead to Building Defect

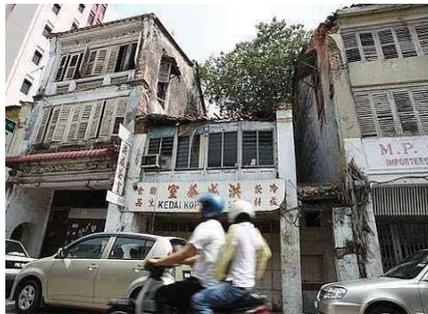
Sometimes, the building façade adds to the height of three storey and this causes the original scale to change and the height of the building is no longer uniform. The front façade is retained and not changed, but additions are made on the back of the building. Height of the rear of the building had been added up to three levels.

This change is not significant if we look at the front of the building, but the reality is that the interior has been thoroughly renovated and has changed the architectural character of the building indirectly by introducing the addition and renovation of this building material, see Figure 6.

This addition also, if not addressed by experienced professionals, will lead to a dangerous structure. The matter is due to the additional burden imposed on the original structure. Increase in height will also prevent the flow of air into the interior of the building. Quality ventilation of old shop houses that rely heavily on air wells are affected (Bill, 1997).

Figure 6: The Height Changes of the Shop House Façade Make the View is No Longer Uniform

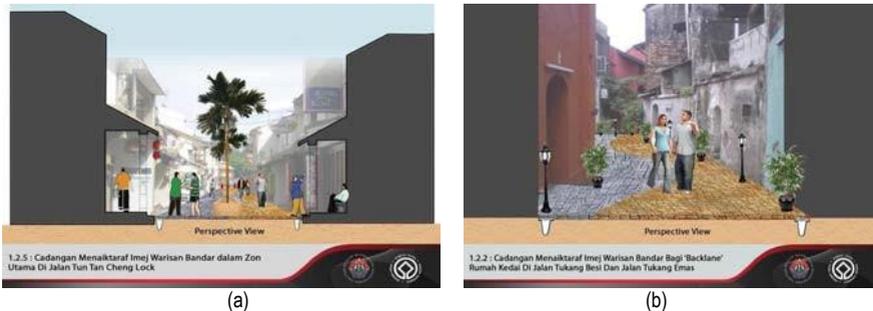
Figure 6: (a) Example of Conservation Planning Design to Avoid Traffic Congestion and Encourage Pedestrian. (b) Example Proposal for Pedestrian Travel at the Back Lanes of the Shophouses to Create Calm and Safety Environment to the Local People and Tourist
