PWDs Accessibility Audit: Commercial complexes, Klang Valley, Malaysia

Abstract

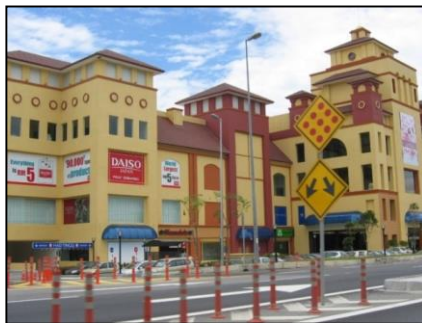
Figure 1: IOI Mall, Puchong, Selangor, Malaysia

The first case study, the IOI Mall in Puchong is a modern 3-storey shopping mall with total areas of 650,000 square feet (Figure 1). The complex was launched in June 1996 with Mediterranean concept of architecture designed. From the survey and on-site audit site, it was found that wheelchair users with limited walking abilities considered the complex as a barrier-free environment. However, the IOI Mall should improve the signage level in the selected areas for easier identification of facilities with safe and clear walking path for people with vision impaired. For respondents with hearing impaired disabilities, they highlighted the important of a clear signage to move without getting assistance. The level of assessment for each group of respondents on the facilities and accessibility available in this complex are as follows.

Item	Group	Perception
1.	Wheelchair user and people with limited walking abilities	Both respondents of wheelchair and crutch categories found that it is easier for them to move around in IOI Mall. However, comprehensive improvements for some areas are needed to ensure equal opportunities for everyone.

2.	Sightless and Vision impaired	Warning indicator is needed to warn person with vision impaired. The indicators help in : Direction - to indicate a clear continuous accessible path of travel, change of floor levels Location - to provide assistance to locate facilities such as pedestrian crossing, entrance to a public building, ticketing machine and phone booth

3.	Hearing impaired	The hearing-impaired people generally do not face many problems accessing most of the facilities at the IOI Mall. The only shortcoming addressed by them is they need proper signage that would enable them to move around without the help of others.

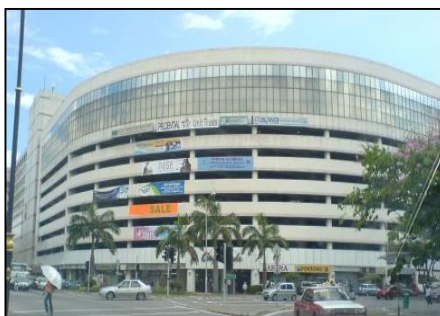
Figure 2: Commercial complex: Ampang Selangor Malaysia

The second complex is located in Ampang, Selangor (Figure 2). This complex is a four storey commercial complex. From the semi structured interviews conducted, it was found that the wheelchair user and people with limited ability faced with challenges especially in term of mobility opportunities within the complex as facilities provided to ease their movement are limited. This is proved by the least score of assessment as shown in Table 2. Others results shows that the vision impaired respondents recorded the second lowest assessment level. Based on the findings shown in Table 2.1, they claimed that the locations of furniture

are not suitable and not easily accessible. They emphasised that devices such as flashing lighting and signal for vision impaired group must be provided.

Item	Group	Perception
1.	Wheelchair user and people with limited walking abilities	The mall area is considered as a barrier-free environment. Comprehensive improvement of the area is needed to ensure equal opportunities for everyone.

2.	Sightless and Vision impaired	The street furniture facilities are not user friendly to the vision impaired people as there are no indicators to locate those facilities. Moreover, most of the furniture are not suitably located and are inaccessible for the PWDs. Male and female toilets are located next to each other and could not easily identified. The layout of corridors is confusing. There are obstructions in circulation routes such as columns and fire extinguishers..

3.	Hearing impaired	The mall is equipped with smoke alarms and other assistive devices to warn the people with hearing impaired, in case of fire. According to United state Fire Administration (2012) clarifies flashing lights are only useful if they are installed where a hearing-impaired person can see them.

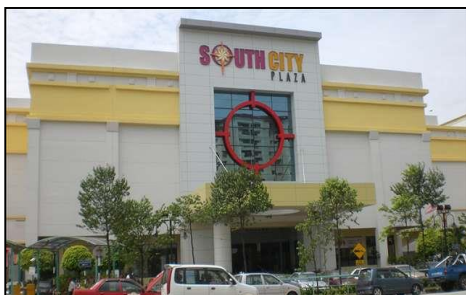
Figure 3: South City Plaza, Seri Kembangan, Selangor Malaysia

The third case study is the South City Plaza located in Sri Kembangan, Selangor. The built up area of this complex is 850,000 square feet. Findings shows that both group of wheelchair users and people with crutches have difficulties in gaining access to facilities such as the toilets due to inadequate size of toilet area and high level of floor drop. For the sightless, they claimed that the signage should be clear with visible lighting level.

Item	Group	Perception
1.	Wheelchair user and people with limited walking abilities	Both wheelchair and crutch users group of respondents found that it were very challenged for them to use certain facilities in this complex. The disabled toilet is inaccessible to the wheelchair users due to the high level of floor drop and the absence of ramp. For the toilet cubicle, although labeled as disabled toilet yet the floor area is inadequate for them to move and use the facilities.

2.	Sightless and Vision impaired	Adequate and proper signage is required to give information, direction, identification and safety to people with vision impaired. Signs must be simple, short and easily understood and need to be suitably lit by good lighting or by use of back illumination and free of reflection. Braille should be used, if possible, wherever embossed characters are used.

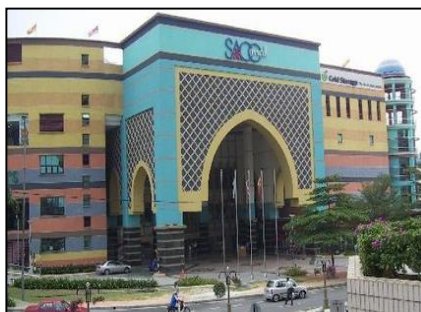
Figure 4: Shah Alam Commercial Complex, Selangor Malaysia

The fourth case study is a six-storey height commercial complex with a gross floor area of 500,000 square feet. As shown in Table 4, the wheelchair users found that accessibility within this complex is not barrier free design. While, others group of respondents found that this complex is a user friendly complex (assessment level range 4 to 5). As shown in Table 4.1, respondents with vision impaired claimed that the building provided a well lit and
